①五十铃MUX上电吸安装说明 (英文版)

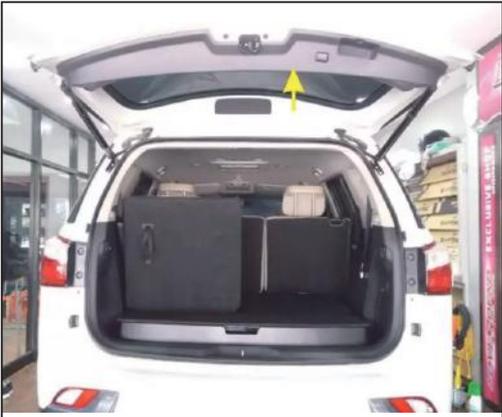
1.Remove the original car trim

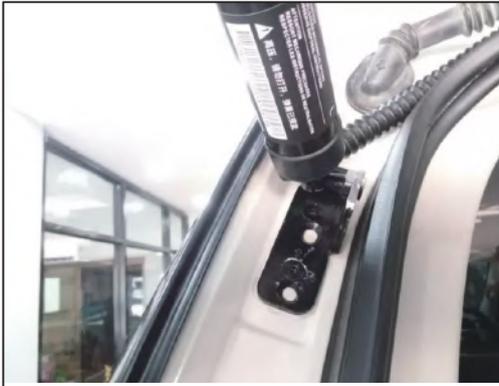
2.Remove the left lower bracket and support rod of the original vehicle, install the left lower bracket of our company, and fix it with our company's screw. Note: Someone needs to hold the door.

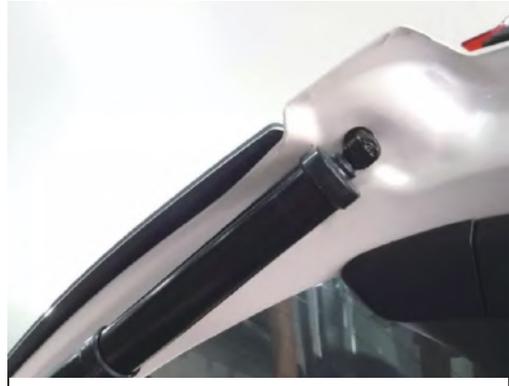
3.Install our support rod with the ball head of the original car (the same steps are left and right)

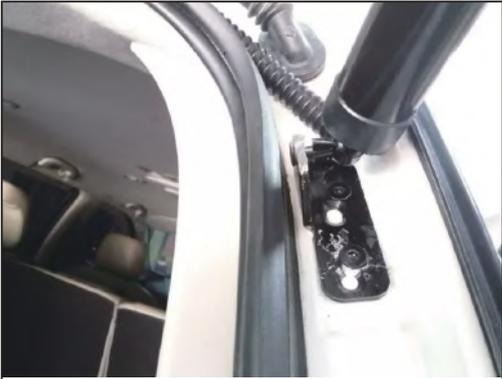
4.Remove the right lower bracket of the original car, install the right lower bracket of our company and fix it with our company's screw

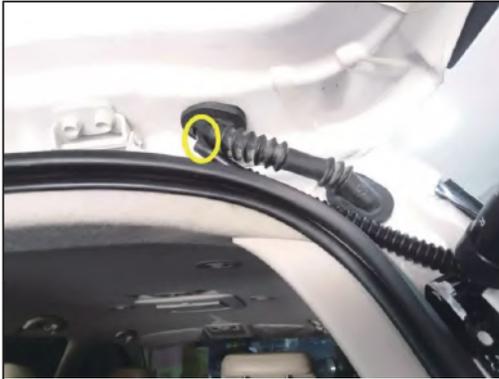
5.Punch holes in the waterproof plug and the Hall line passes through the holes.

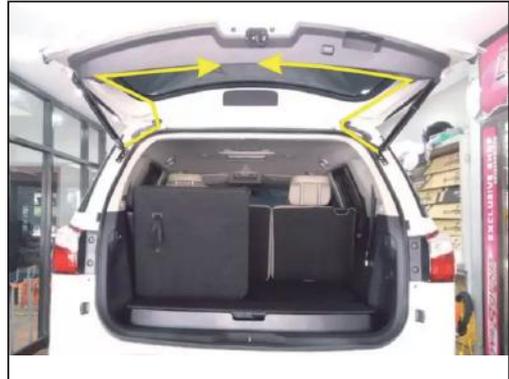
6.Hall wire goes through the rubber plug to the tail door cover

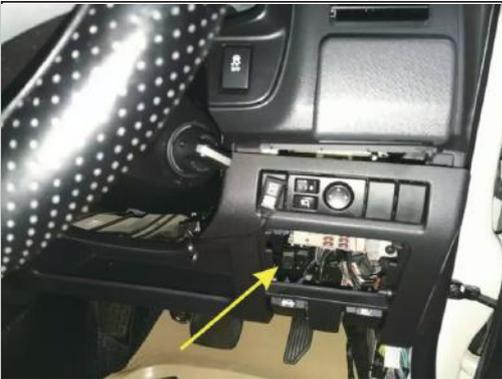
7.Find power on the right side of the main driver

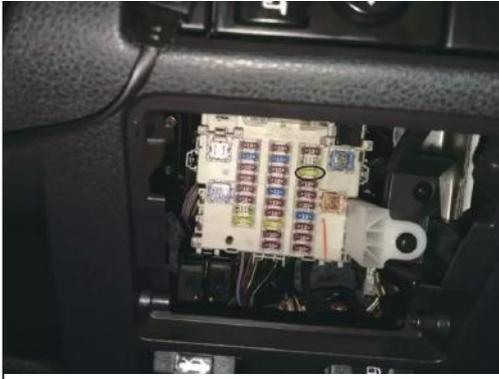
8.Unplug the 20A fuse of the original car

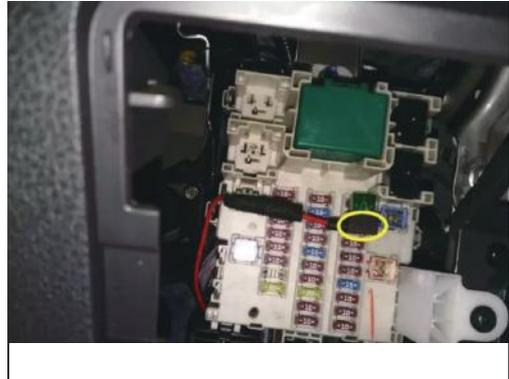
9.Plug in our power plug

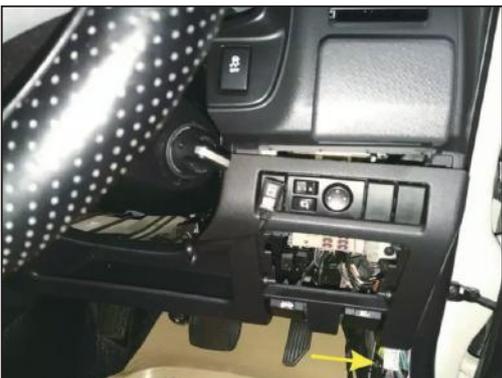
10.Remove the trim at the lower right of the power supply and find the ground wire

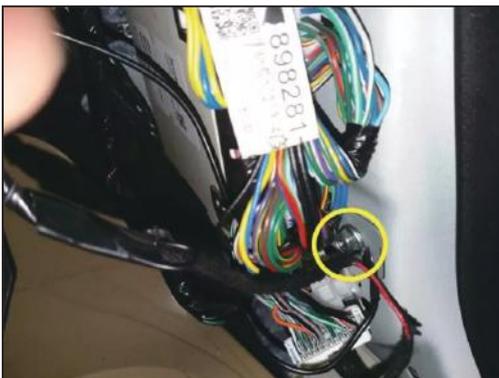
11.Connect Ground Wire

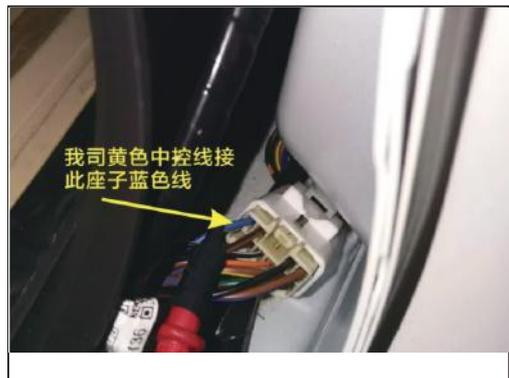
12.Remove the trim board at the B pillar of the right main driver's seat belt and find the original car central control. Our company's central control wire connects the blue line of the seat.

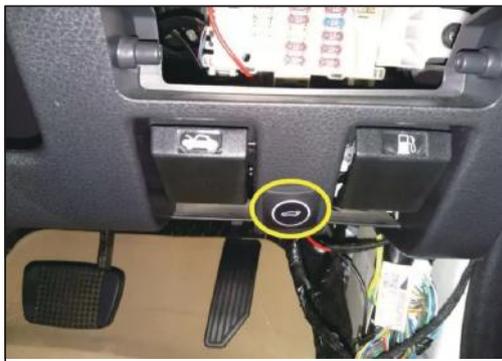
13.Punch holes in the lower panel of the power supply and install the front switch of our company

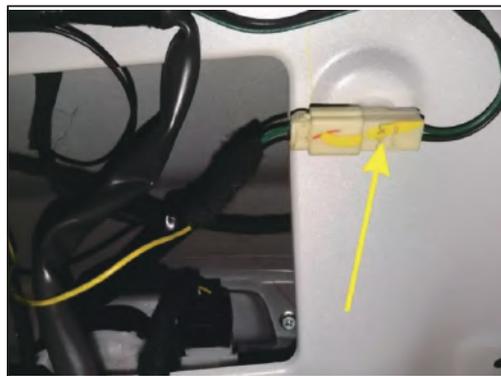
14.Find this seat at the tail gate

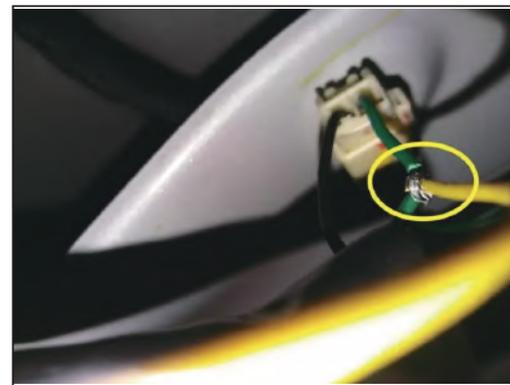
15.Our Yellow Wire Connects the Green Wire of this Seat

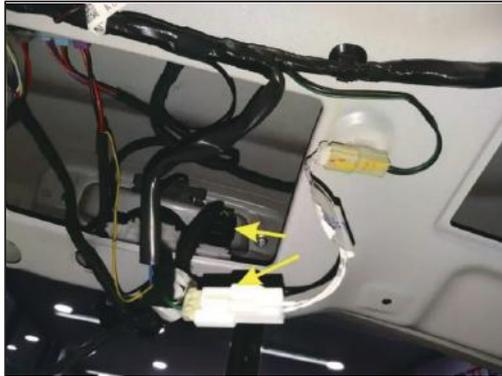
16.Pull out the plug at the rear door lock and plug in the three-way socket of our company. The other end plug of our company's three-way socket is plugged in the original door lock.

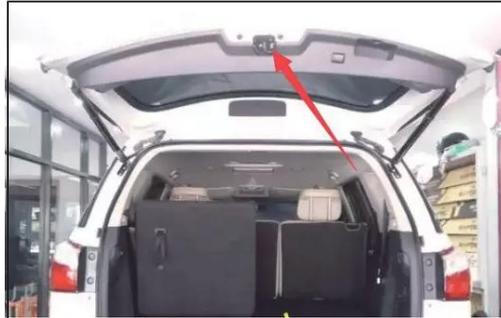
17.Remove the original locks

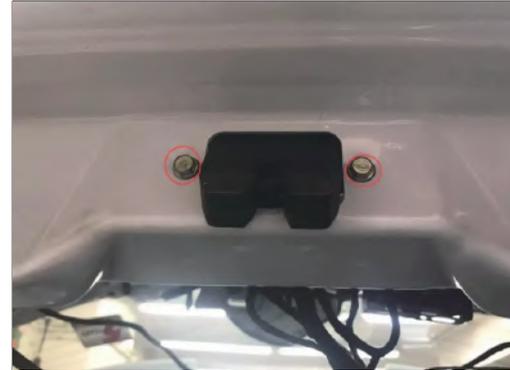
18.Install our electric suction lock and fix it with original screw

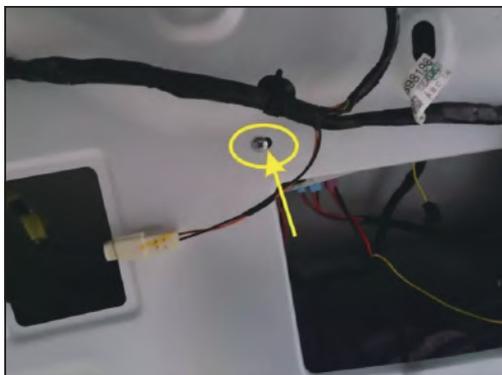
19.Install our central control box and fix it with our screw and gasket

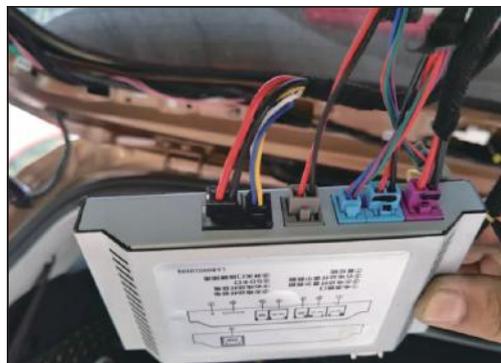
20.Plug Hall wire, power cord and electric suction wire into control box one by one according to color

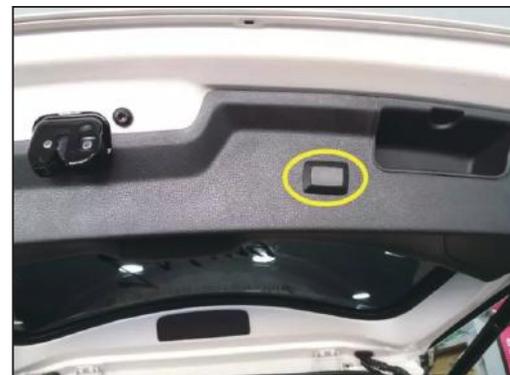
21.Punch holes in the tail door panel, install the tail door button of our company, and restore the panel.
